HQ LEAD NUMBER: FY13-105018-3714-CV

District Department of the Environment

Natural Resources Administration
Water Quality Division

**Illicit Discharge Investigation Report****Case Number:** 100330**Complaint:** Routine monthly facility inspection**Location:** 1711 1st St., SW (Super Salvage, Inc.)**Date Incident Reported:** March 30, 2010**Date of Investigation:** March 30, 2010**Name of Inspector(s):** Ibrahim Famuditimi and Jacob Zangrilli

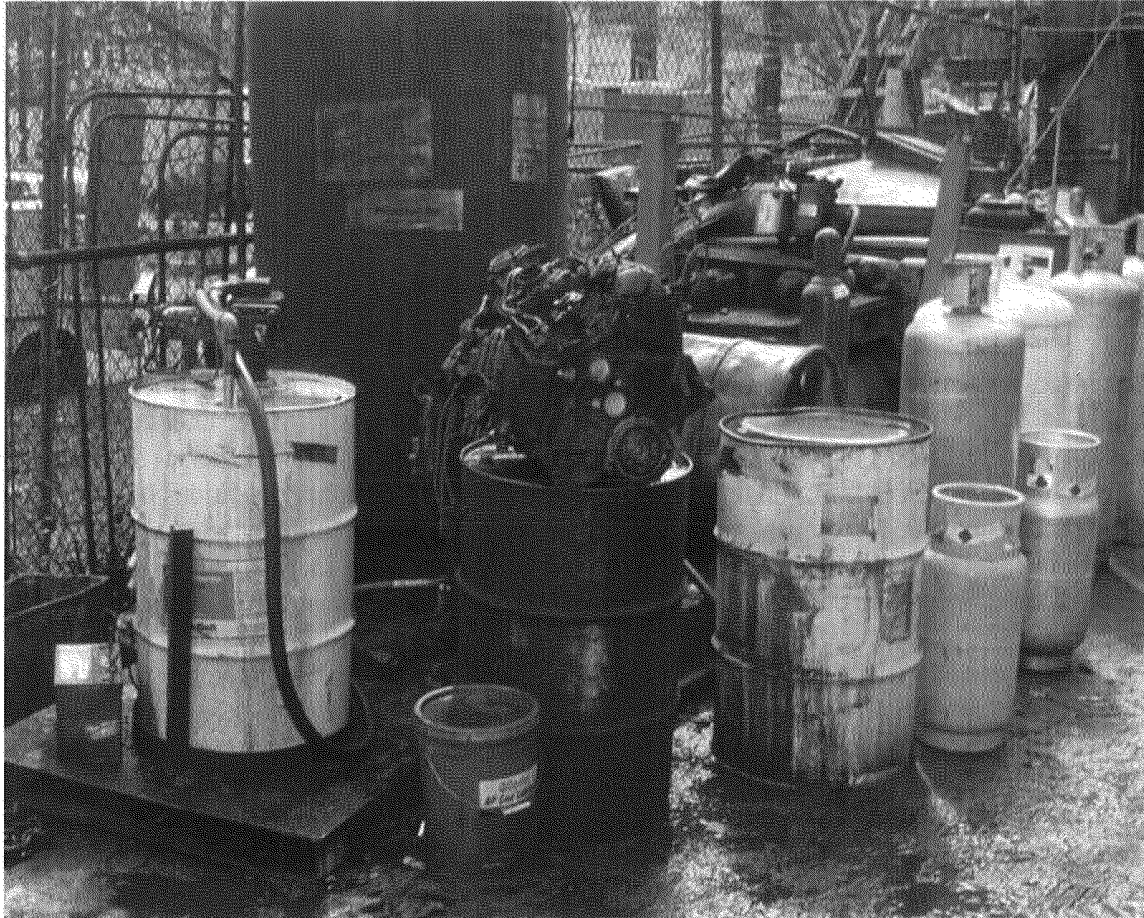
Waste material storage at 1711 1st St., SW

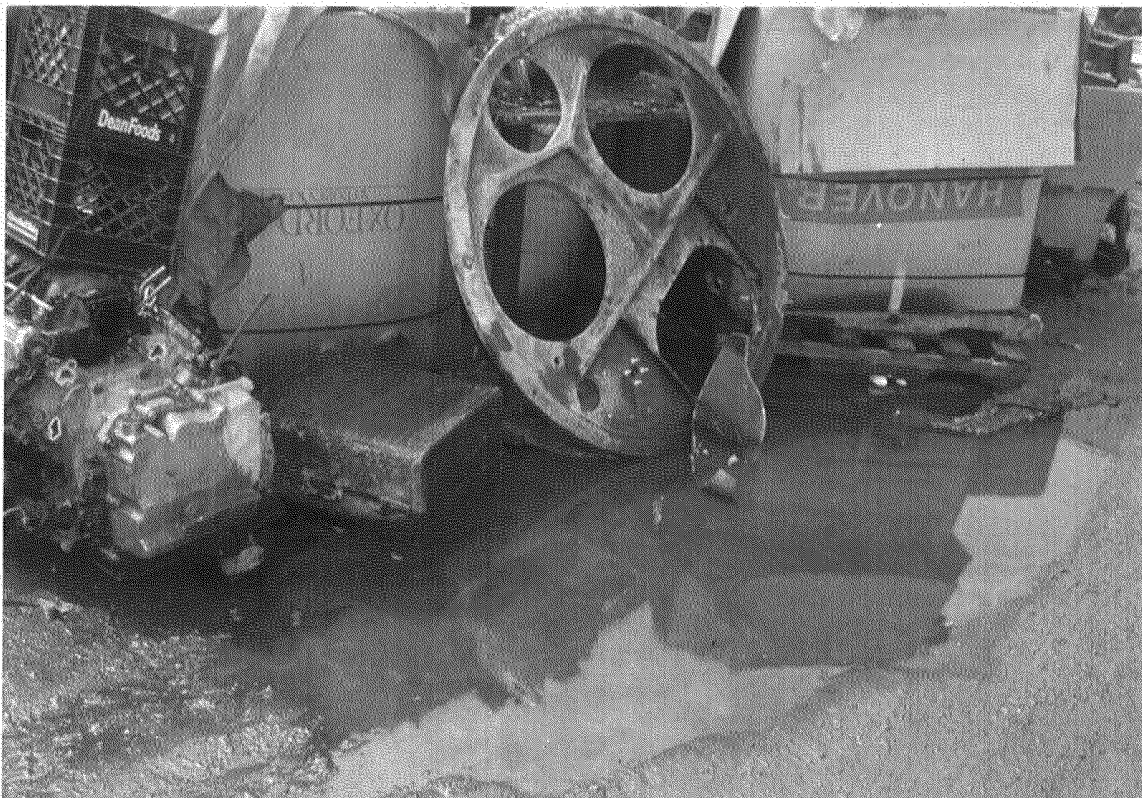
Inspectors noticed various types of fluids leaking from storage boxes left on the grounds of the property, automotive parts, and also from buildings on the property. Upon asking why fluids were coming out of the buildings, inspectors were told that they had a malfunction with the hydraulic equipment the day prior, and they are working on fixing that problem. During the time of inspection, the hydraulic equipment was turned off. Inspectors also noticed what seemed to be a concrete hole in the ground. Mr. Bullock told inspectors it was used for collecting runoff fluids on the property. Mr. Bullock stated that this "runoff collection unit" is later pumped into the pond of the back of the building. An employee on site disagreed with Mr. Bullock and said that contractors came to pump liquids from the concrete hole, and that it was a closed catchment system. When asked to see documentation that such fluids are been picked up, Super Salvage was unable to locate the paper work.

Storage boxes leaking of fluids at 1711 1st St., SW

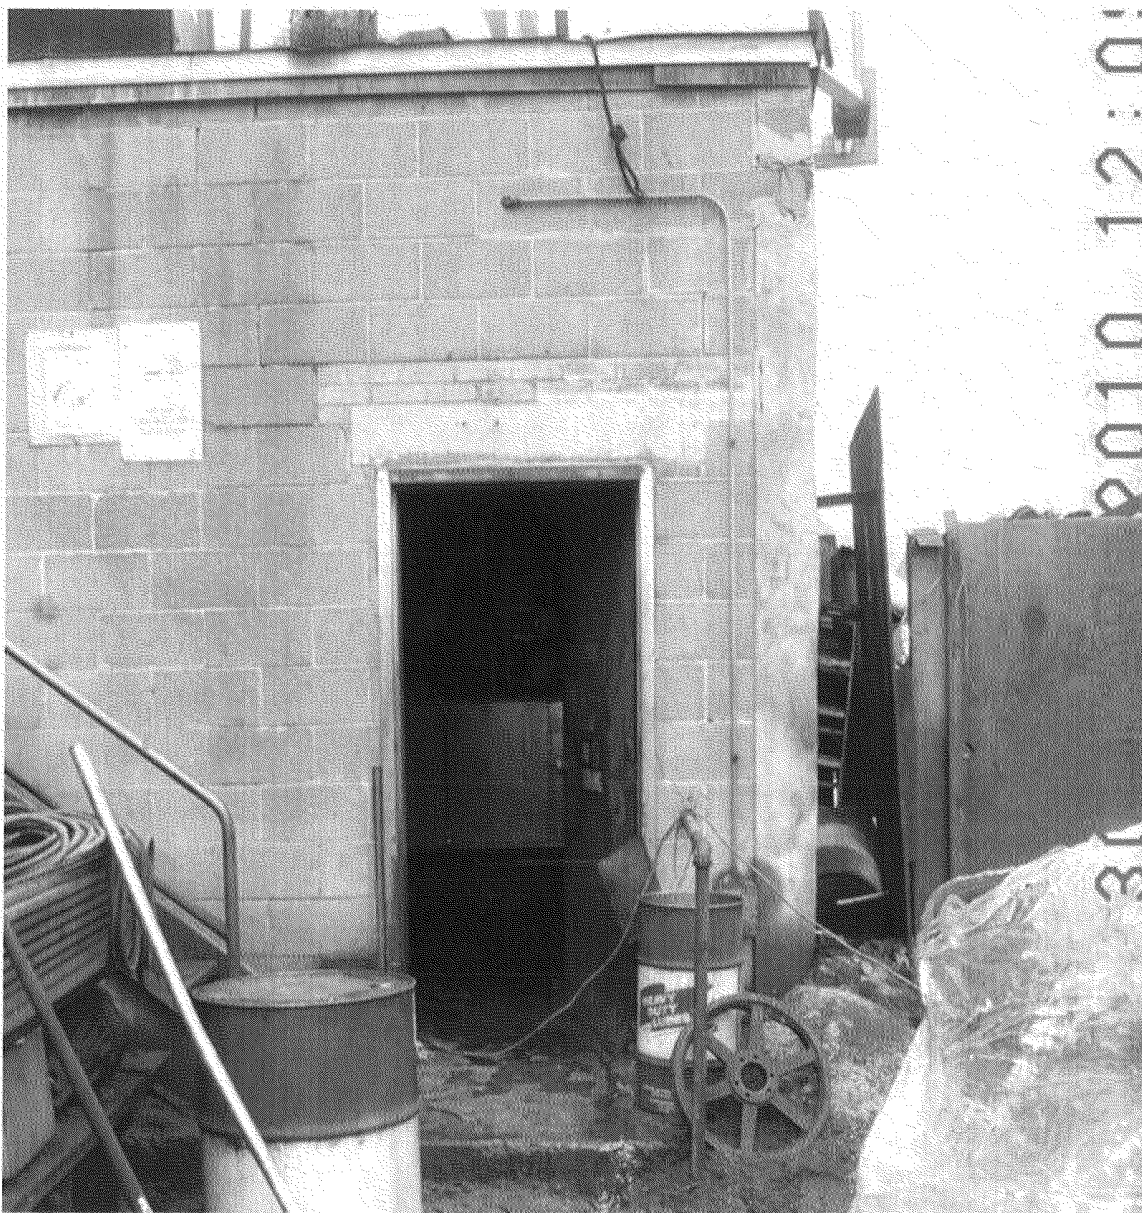
Equipment building with fluids coming out it at 1711 1st St., SW

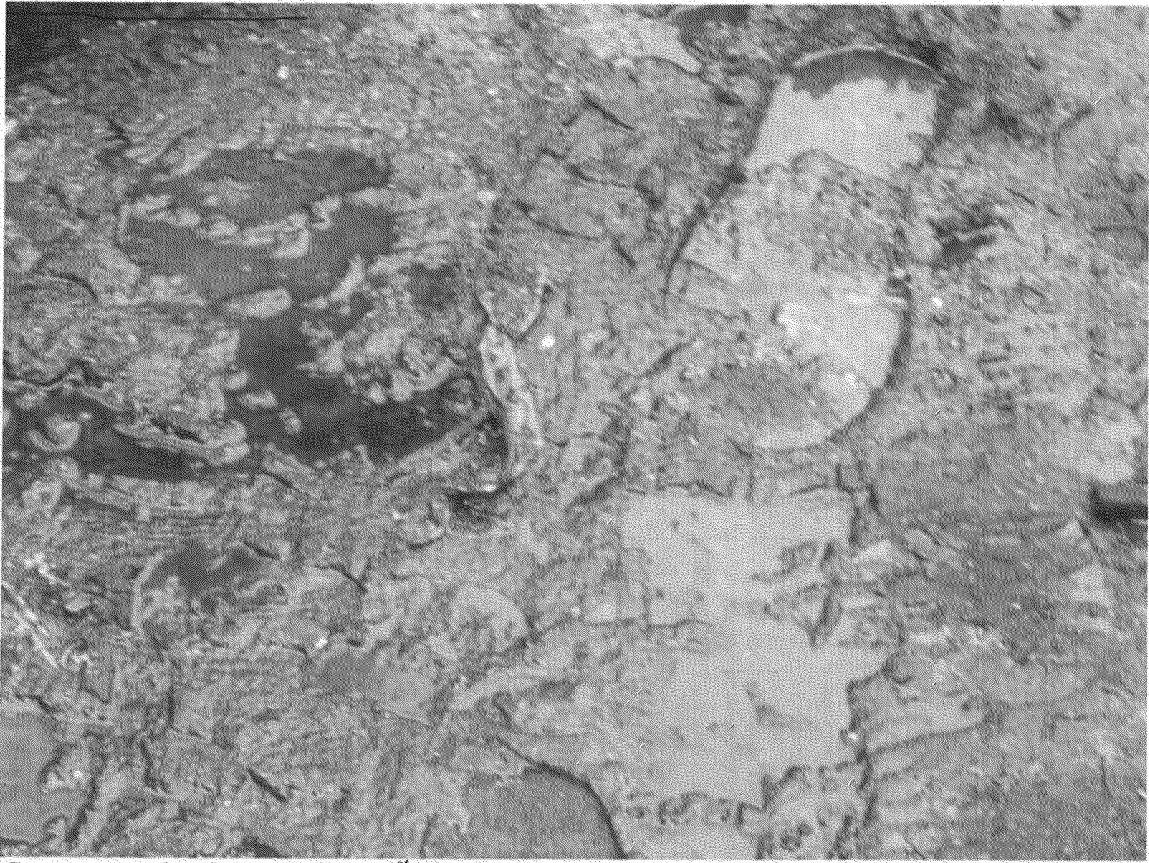
Contaminated soil area at 1711 1st St., SW

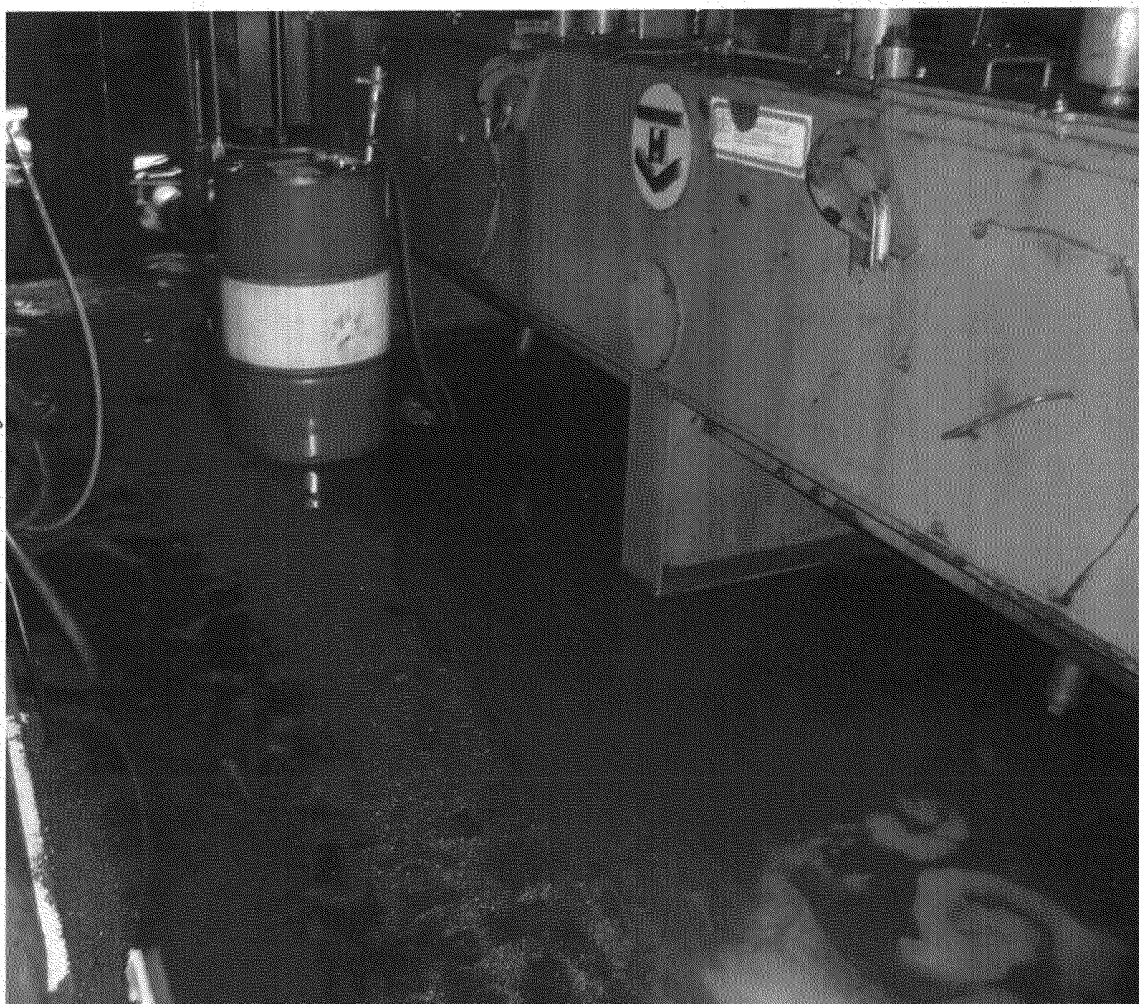
Equipment Building showing fluid on the floor at 1711 1st St., SW

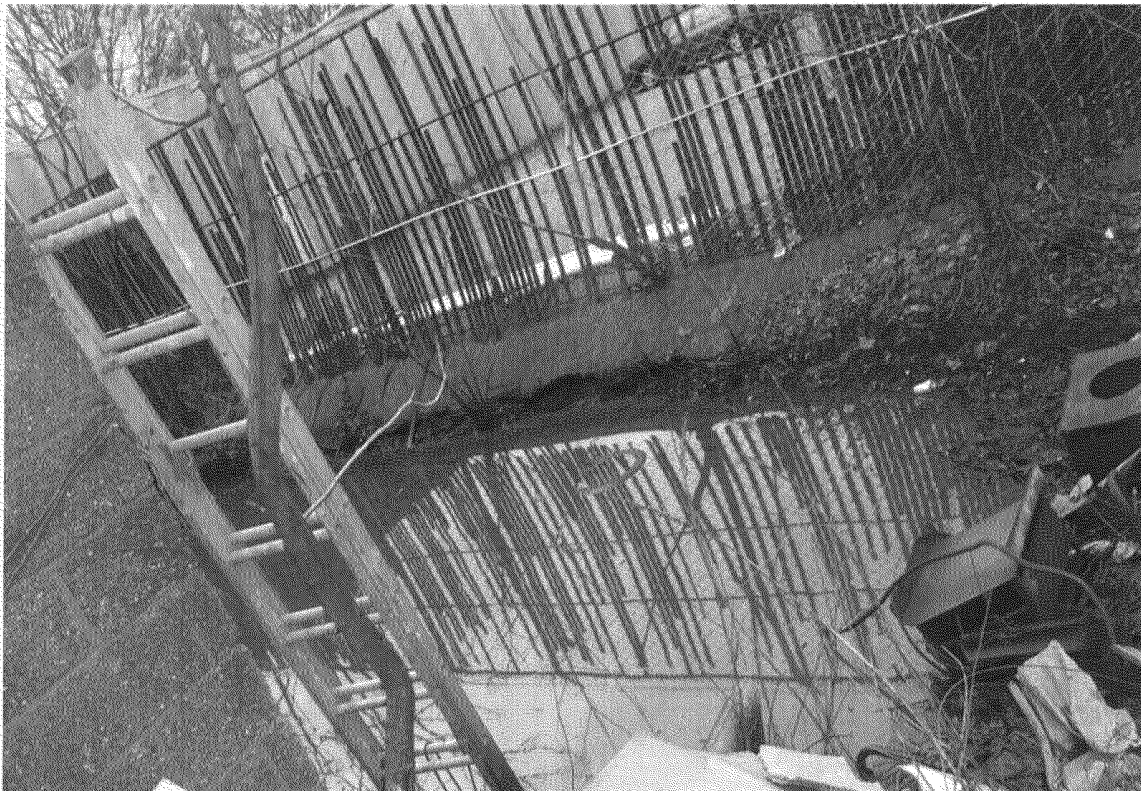
Inspectors also noted a large pond-like structure behind one of the equipment buildings which was filled with a mix of water and various unknown fluids. When asked why such a pond existed, Mr. Bullock stated that for several years they have always pumped such liquids into the hole which they allow to drain into the ground or evaporate. A majority of this property is not paved, and it is also apparent that the operations at this facility have resulted in severe contamination to soil in and around the property.

Hole in the ground with different pumped liquids at 1711 1st St., SW

Water Quality Division inspectors are recommending that we have a multi-media inspection that also includes other District and Federal agencies. Directives should be issued to prevent future contaminated runoff from impacting ground or surface water in the District.
